PERATION

GREENHOUSE

SCIENTIFIC DIRECTOR'S REPORT

ANNEX 3.2 U. S. NAVY STRUCTURES

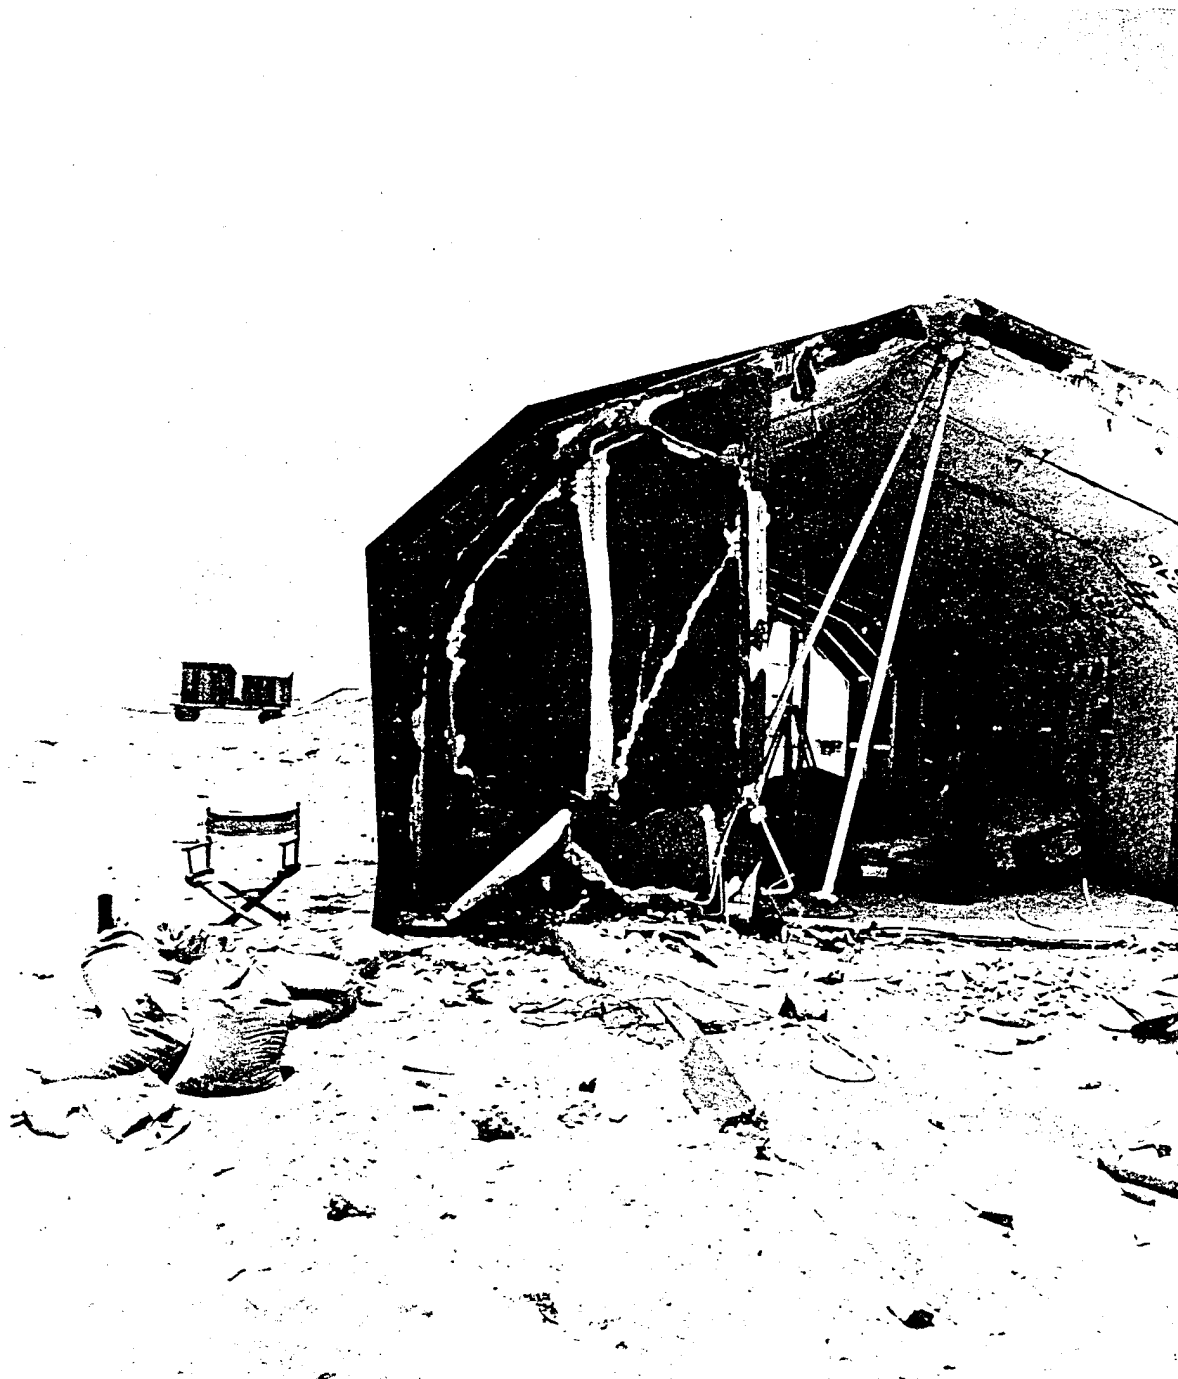
Fig. L. 365 Exterior View of Front Right End Panel, Structure 3.2.4b. Note the center rib lying in center foreground.

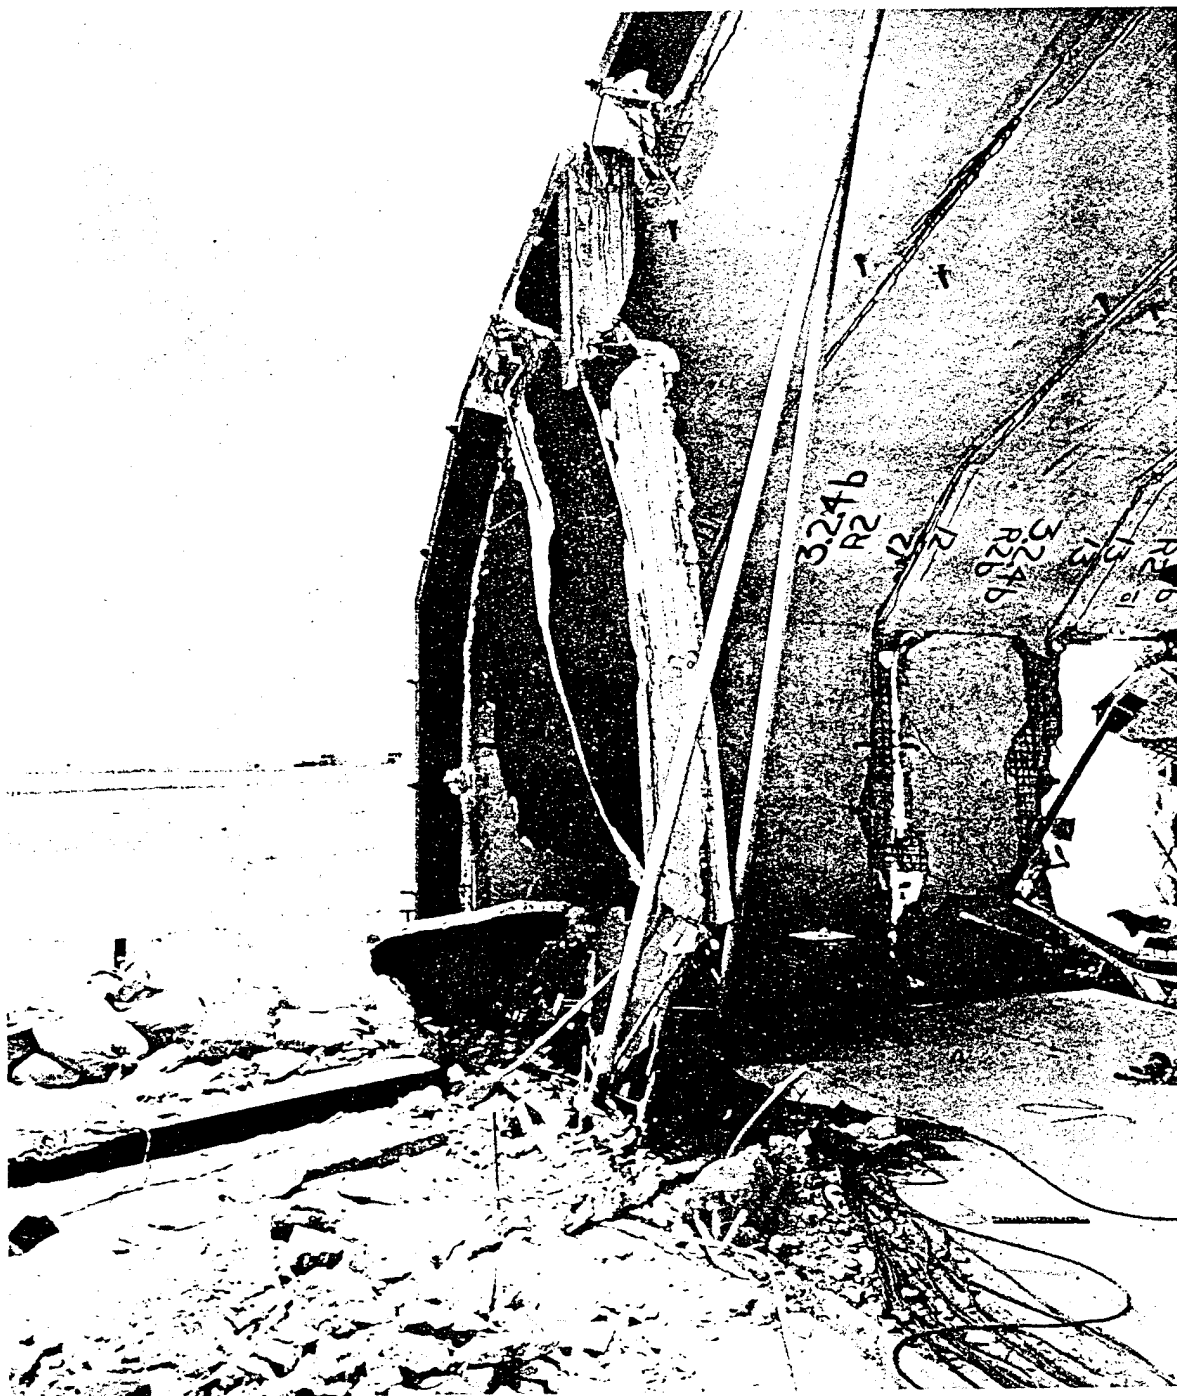
Fig. L.366 Diagonal Exterior View of Front Right End Panel, Structure 3.2.4b

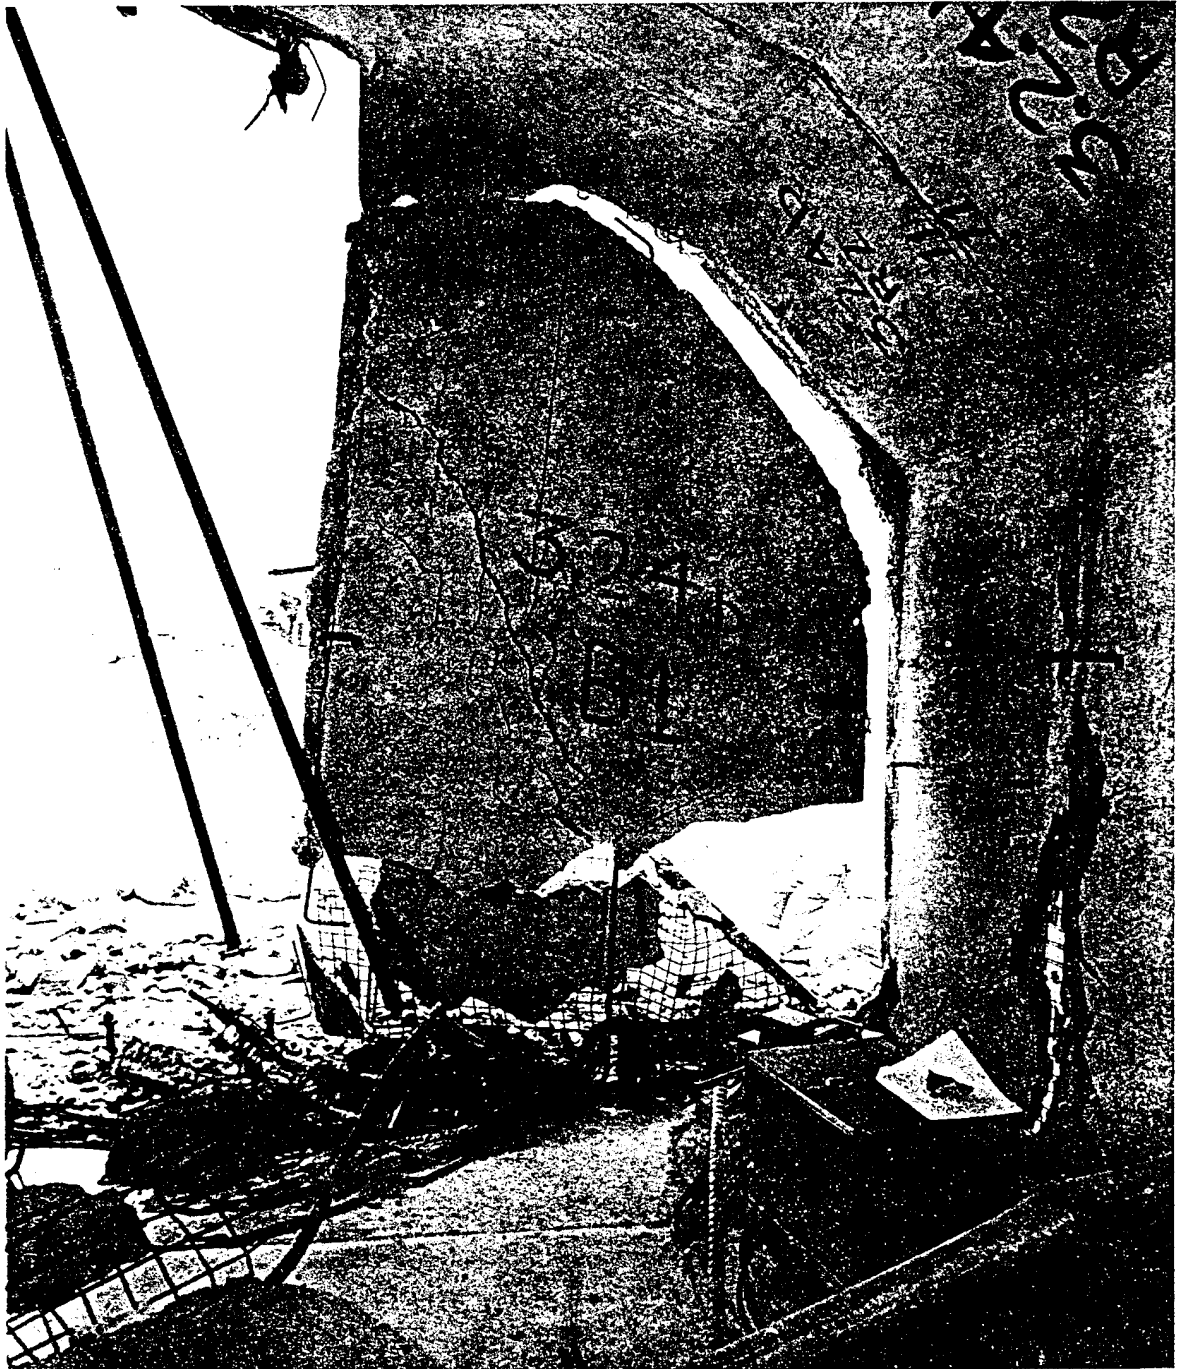
Fig. L. 367 Interior View of Front Right End Panel, Structure 3.2.4b

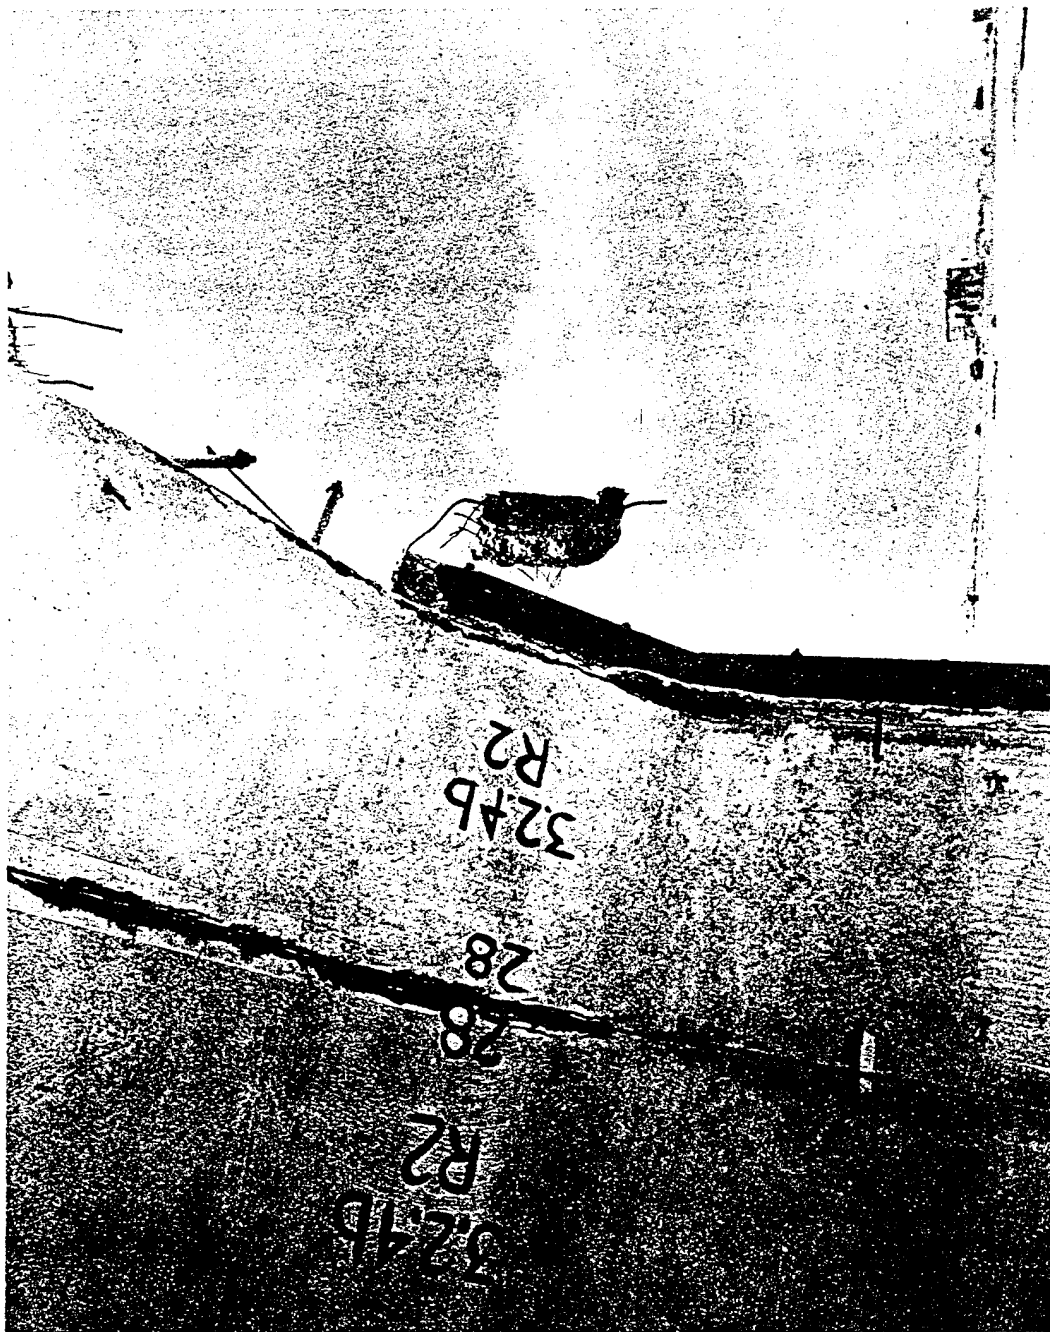
Fig. L. 368 Upper and Rear Ribs of the Rear Right End Panel, Structure 3.2.4b

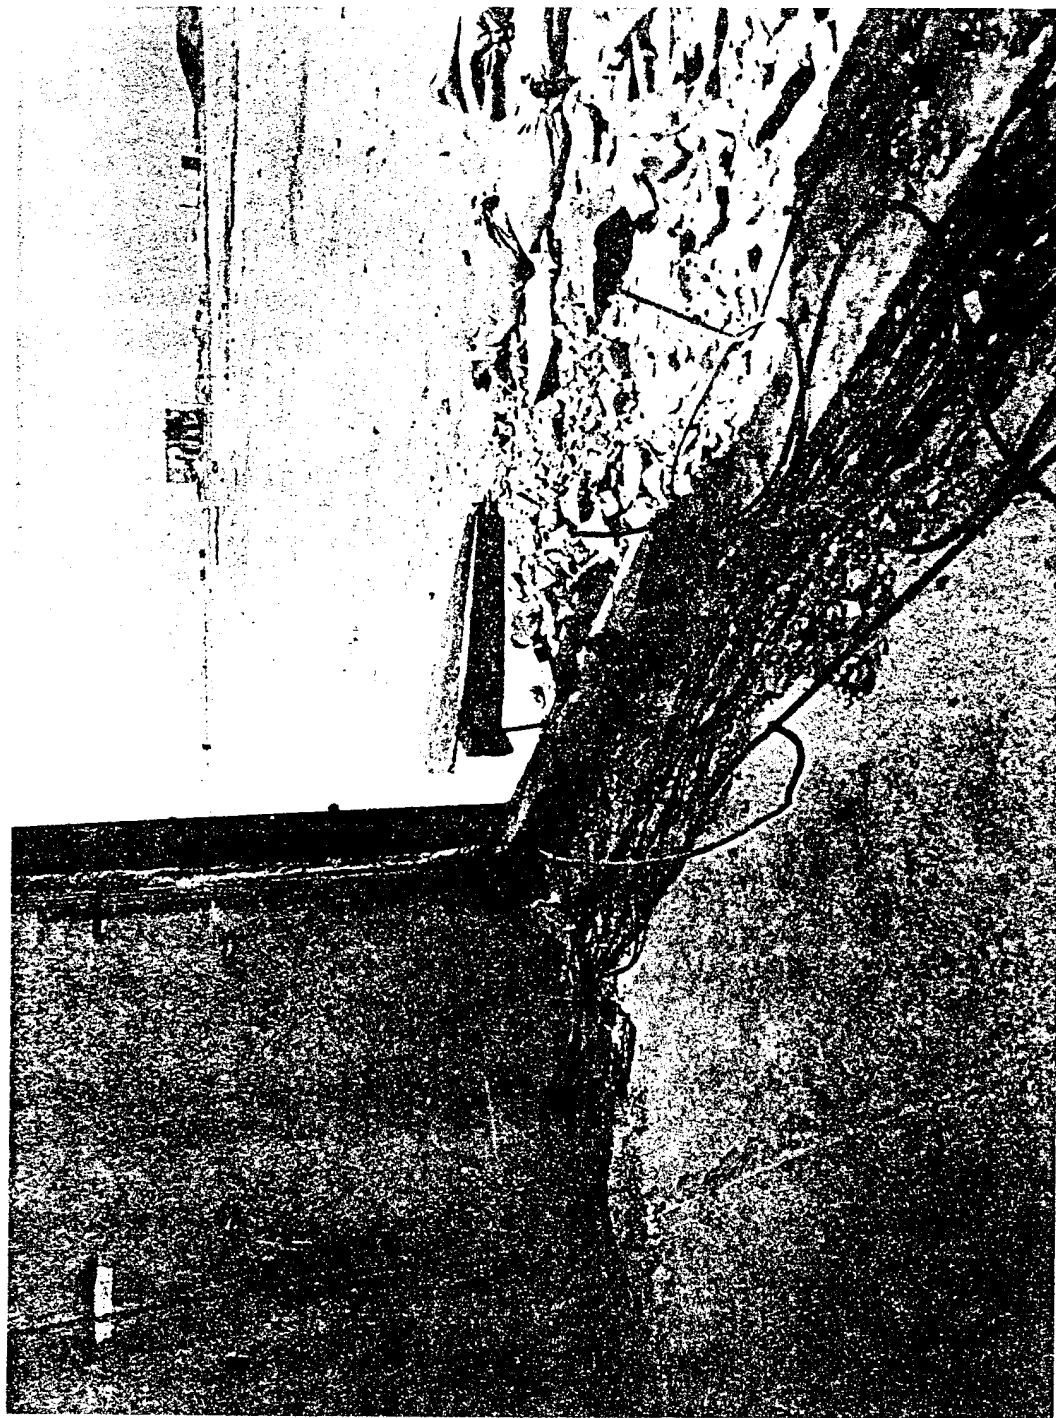
Fig. L. 369 Bottom Rib and Rear Rib of Rear Right End Panel, Structure 3. 2. 4b

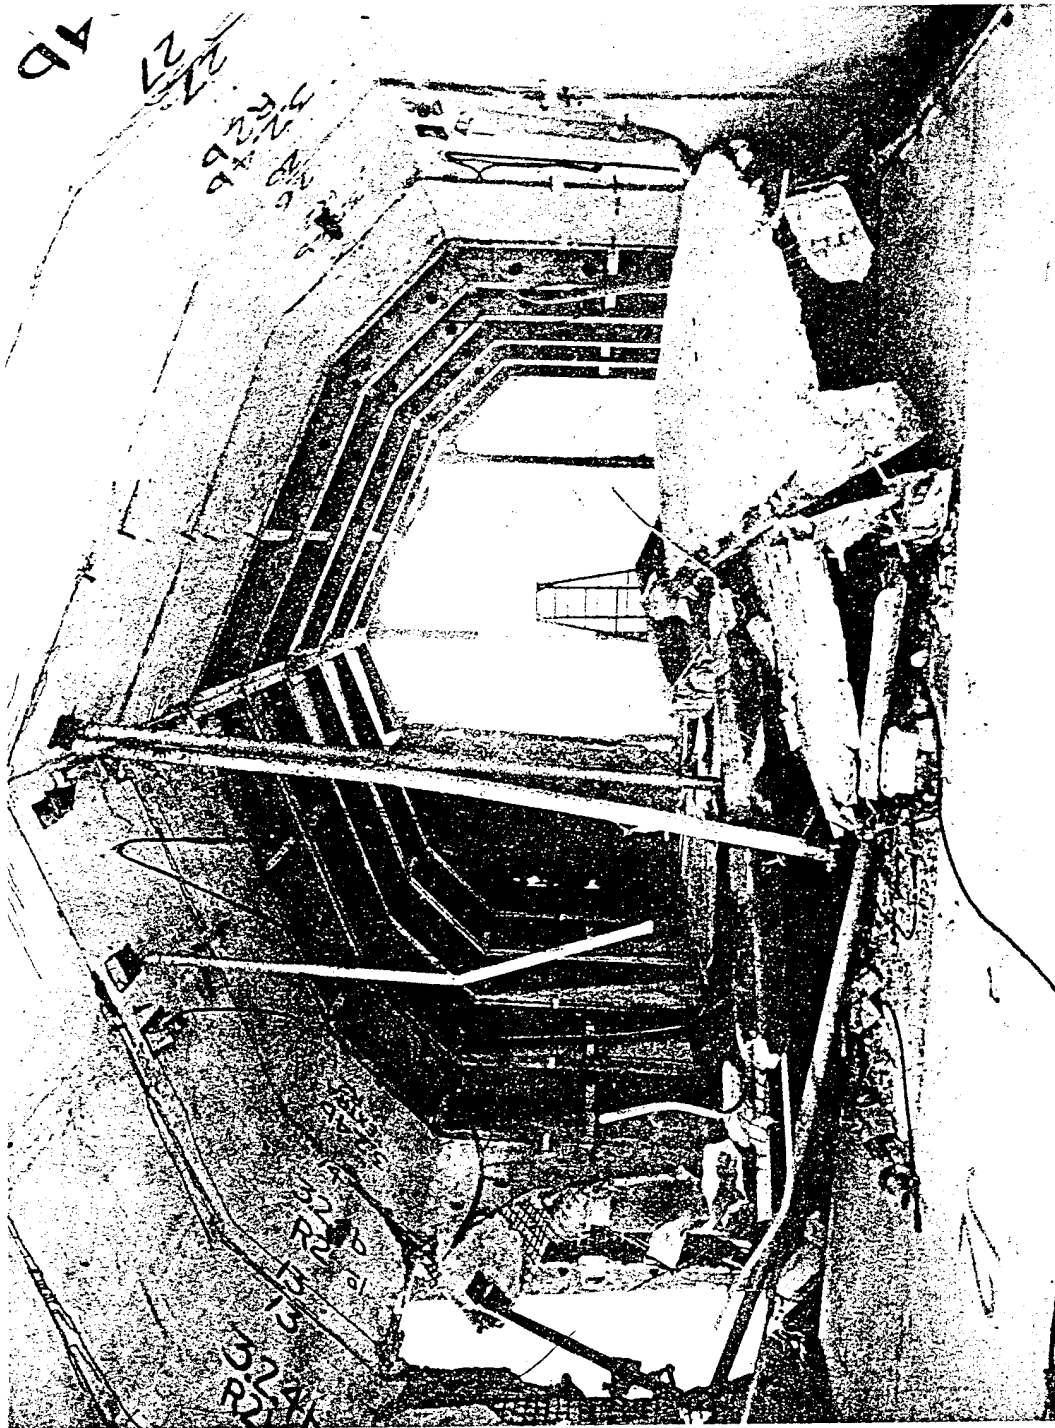
Fig. L. 370 Final Position of Center and Rear Right End Panels in Right Foreground, Structure 3.2.4b

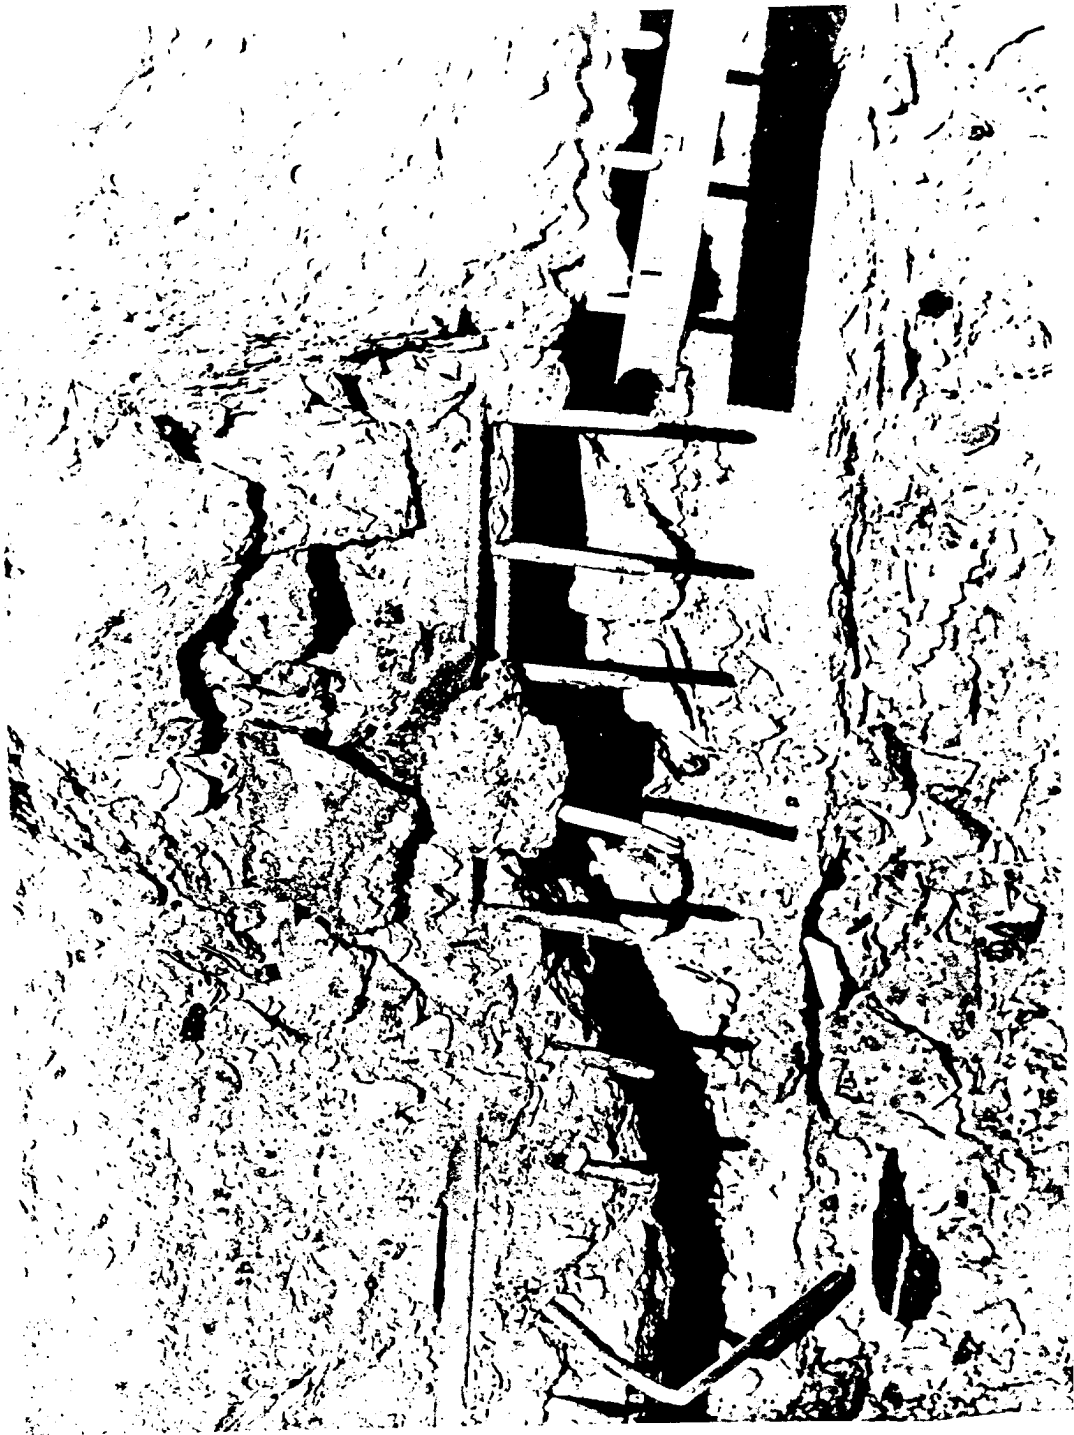
Fig. L. 371 Typical Detail of Mesh Failure in End-wall Diaphragms, Structure 3.2.4b

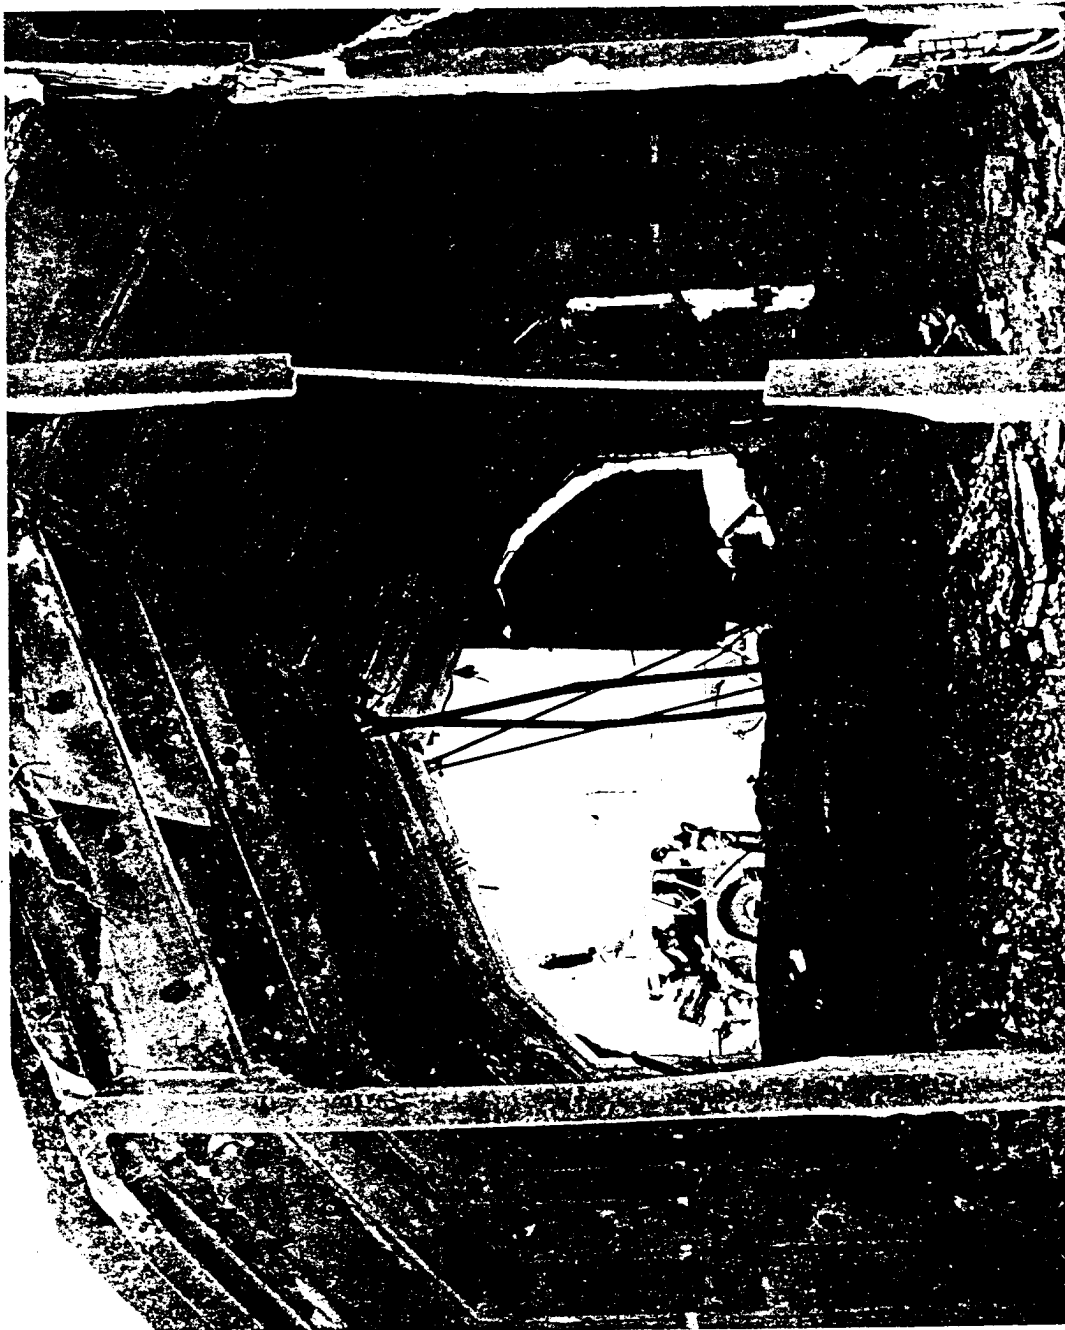
Fig. L. 372 Exterior View of Remaining Ribs of Center and Rear Left End Panels, Structure 3. 2. 4b

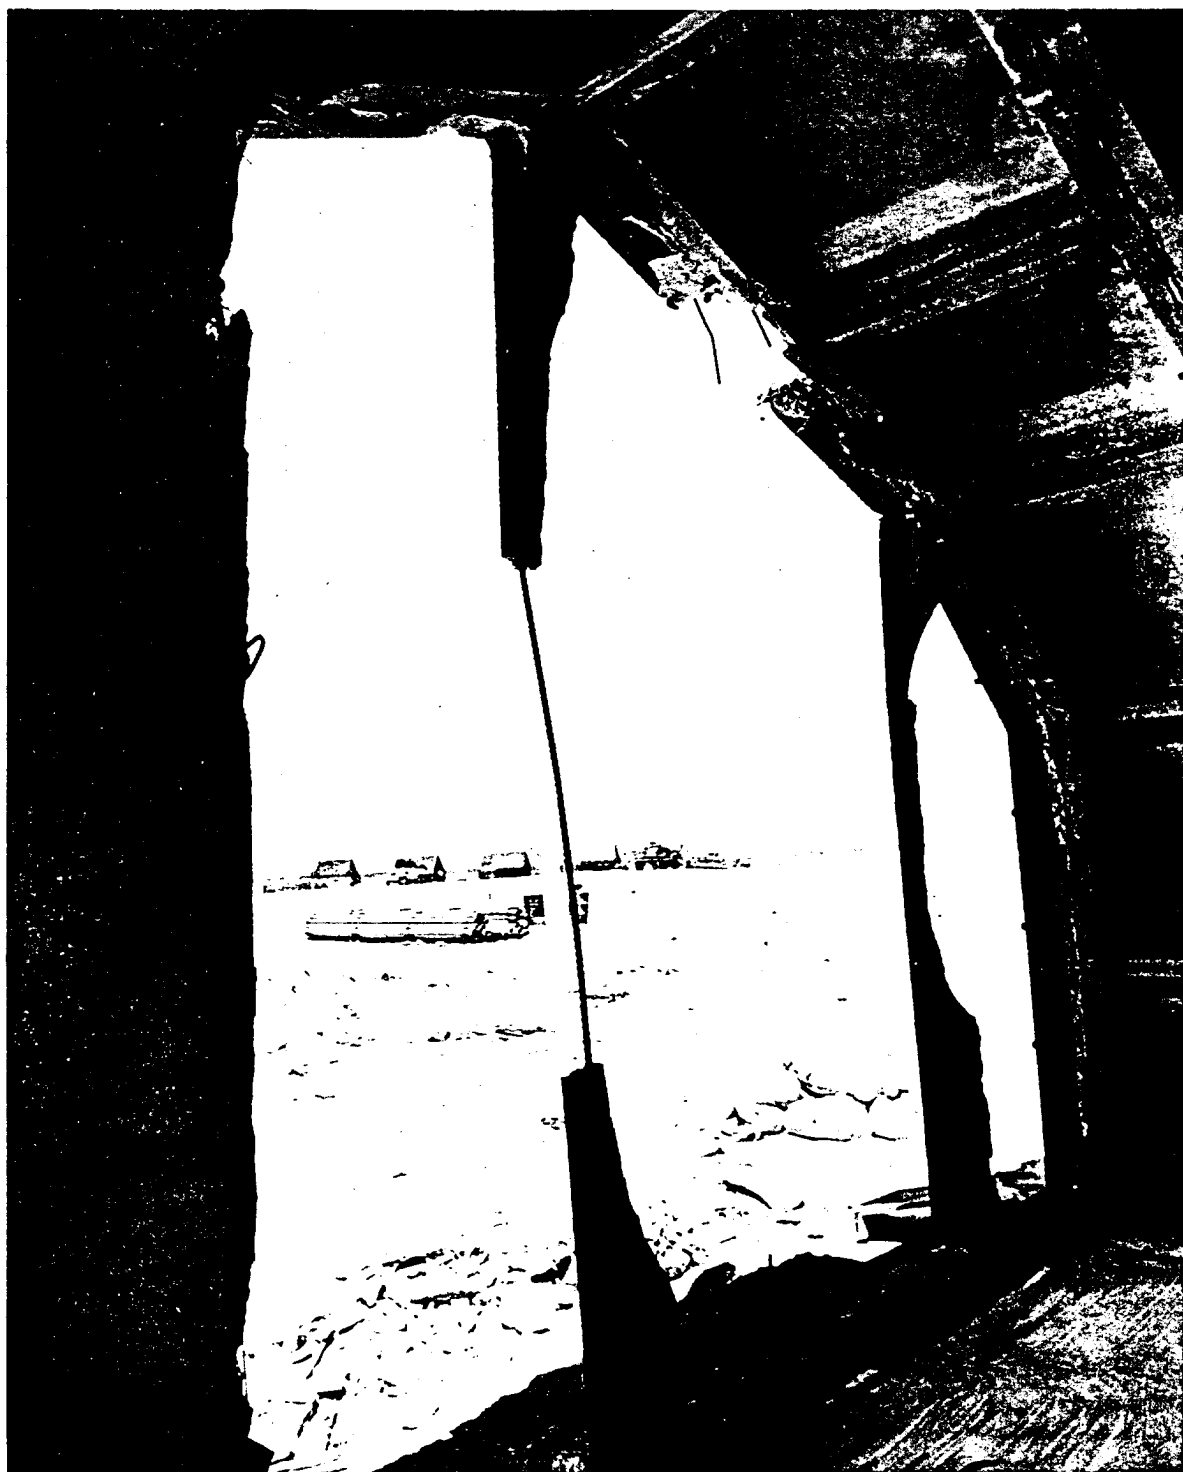
Fig. L.373 Interior View of Remaining Ribs of Center and Rear Left End Panels, Structure 3.2.4b

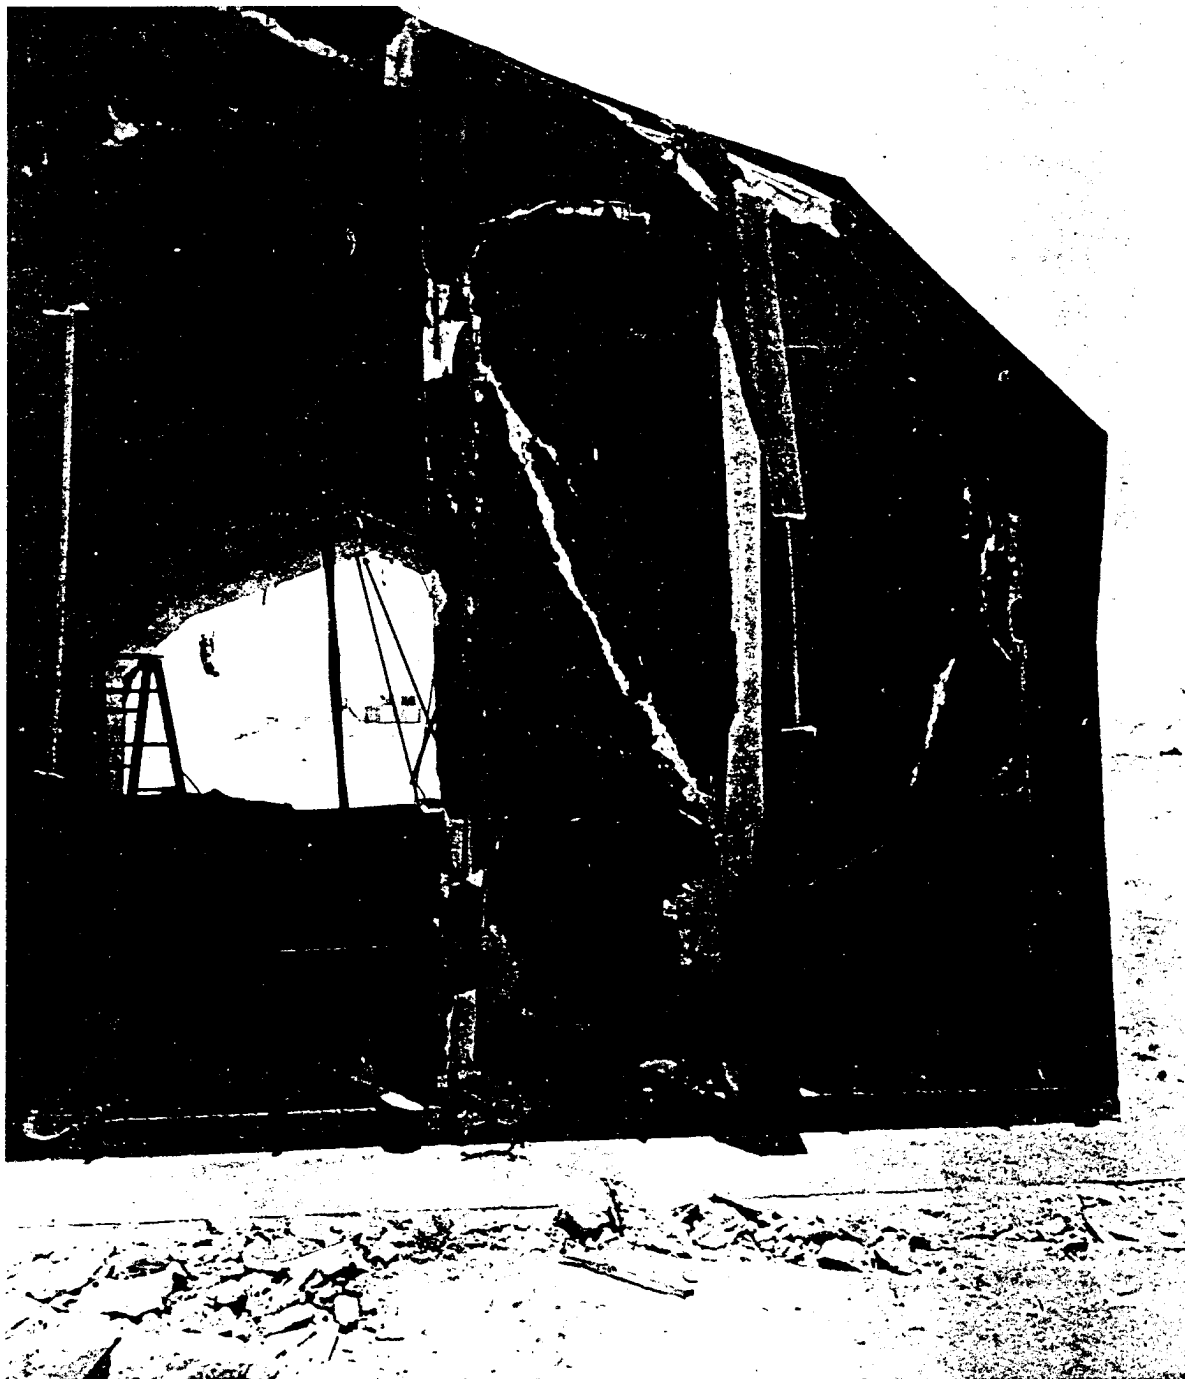
Fig. L.374 Exterior View of Front Left End Panel, Structure 3.2.4b

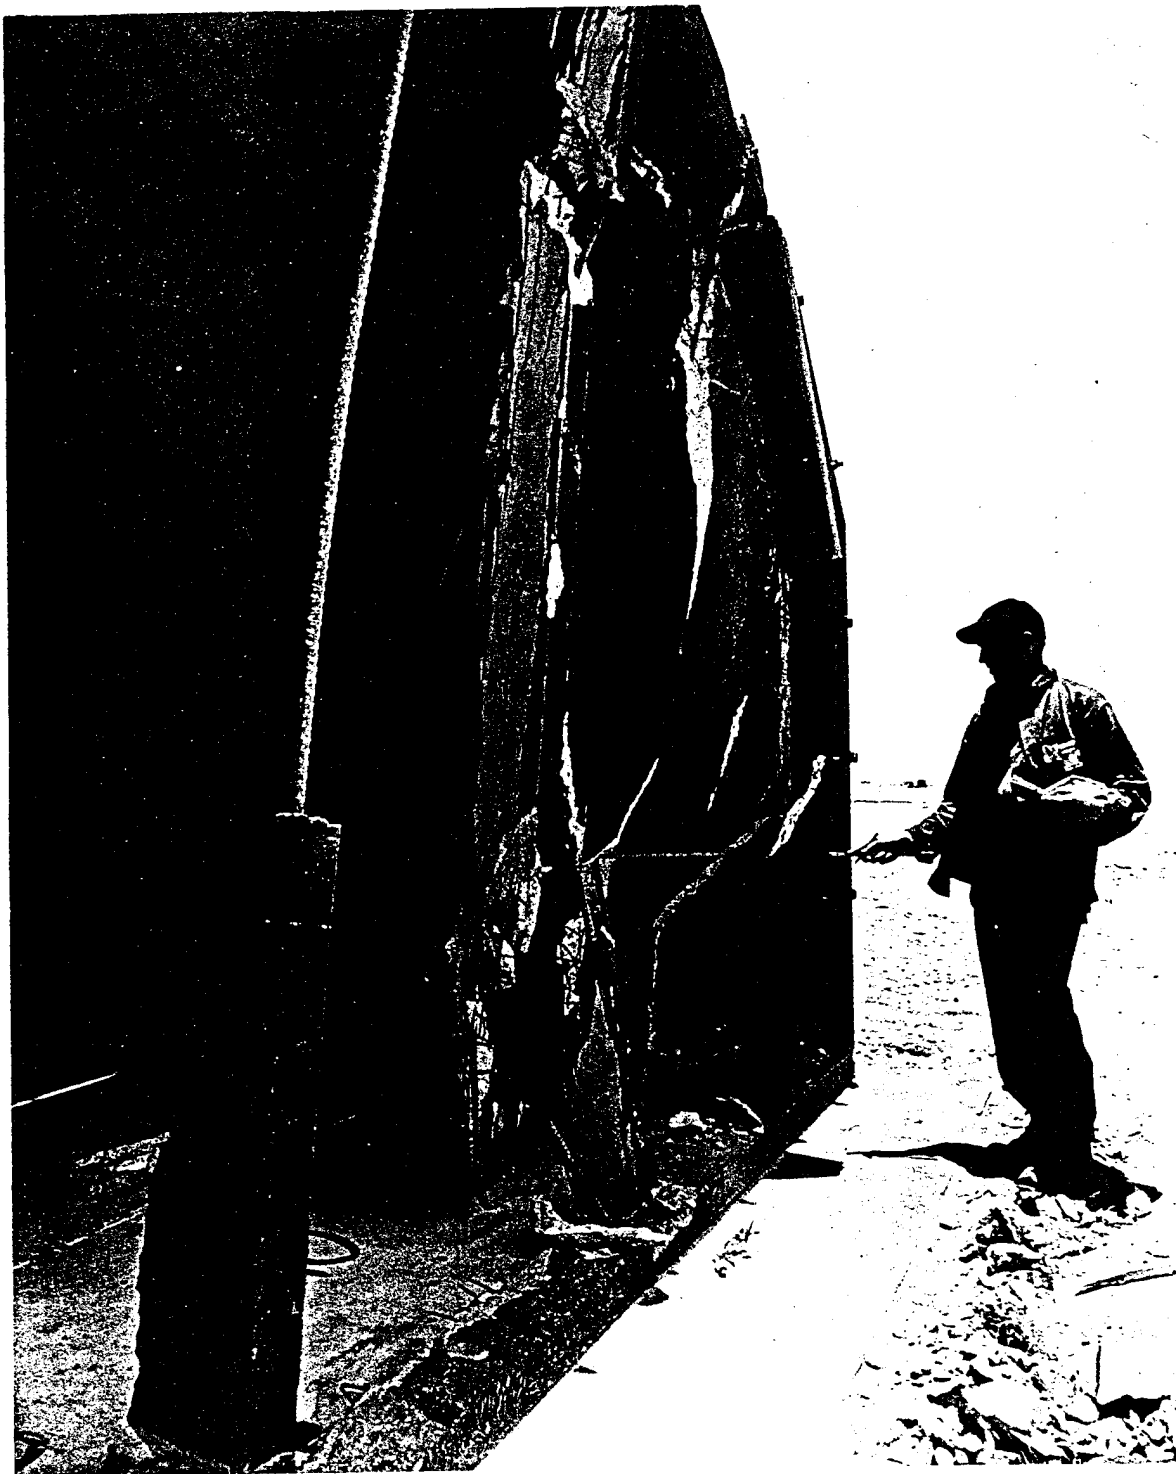
Fig. L.375 Diagonal Exterior View of Front Left End Panel, Structure 3.2.4b

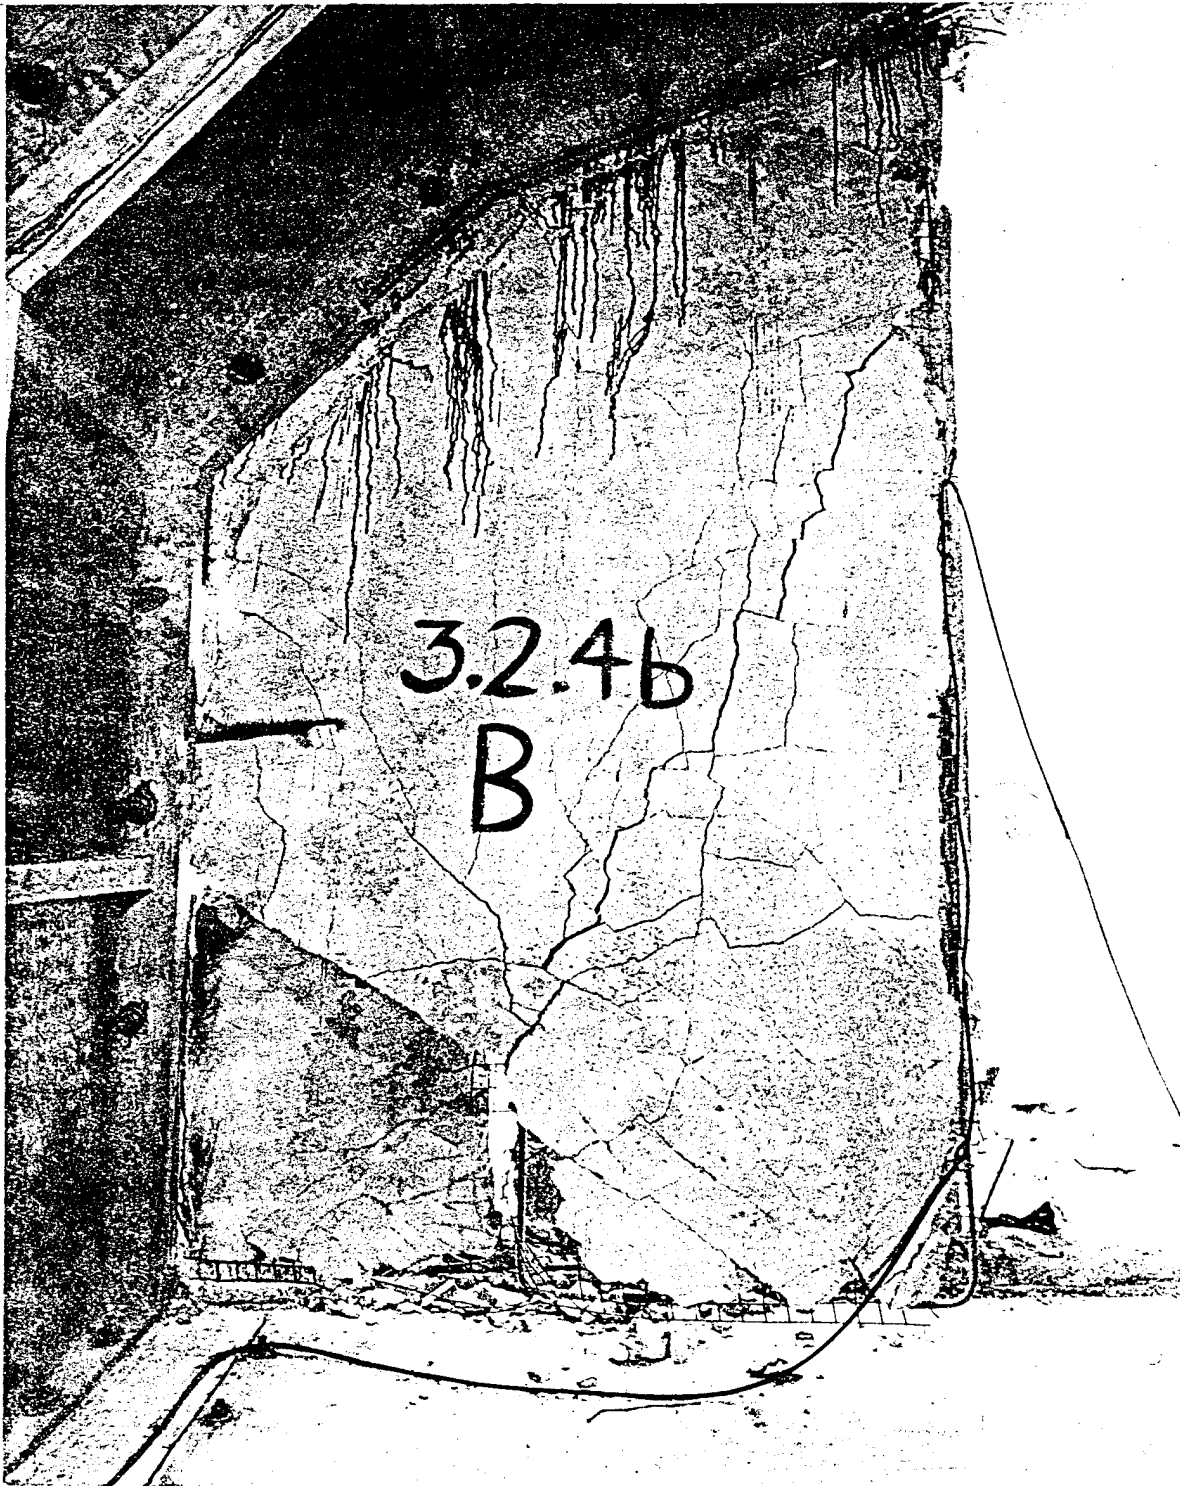
Fig. L 376 Interior View of Front Left End Panel, Structure 3.2.4b

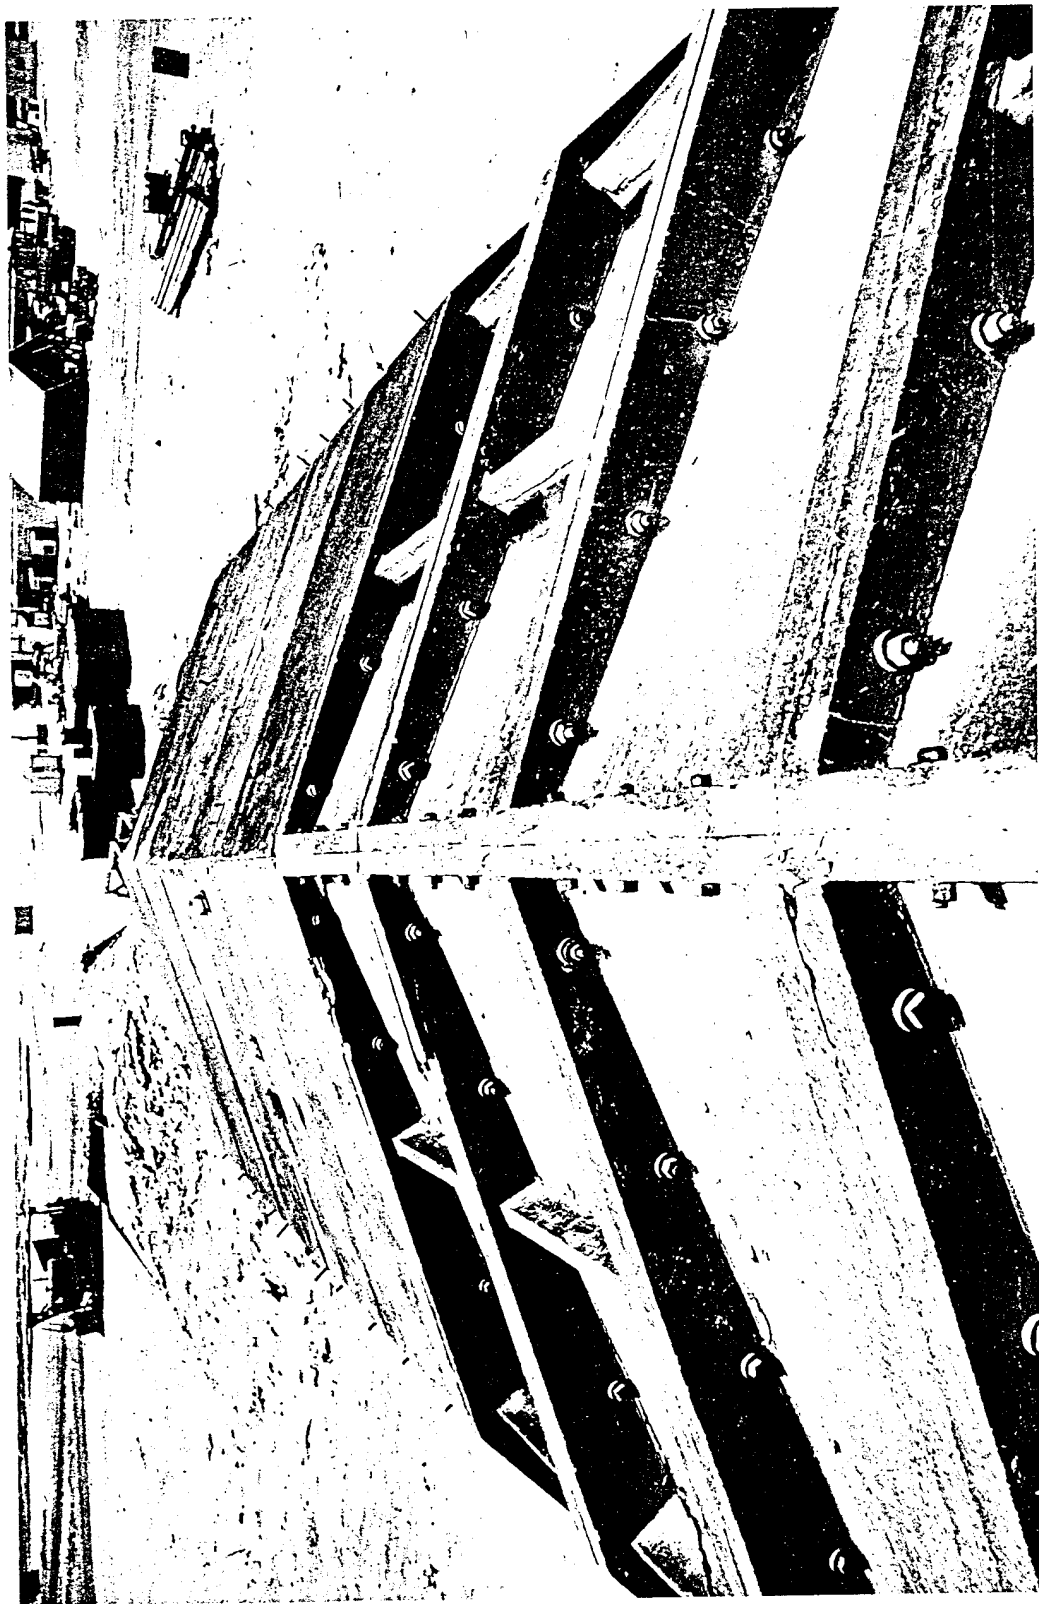
Fig. L. 377 Exterior View of Roof Sections, Taken from Right End, Structure 3.2.4b

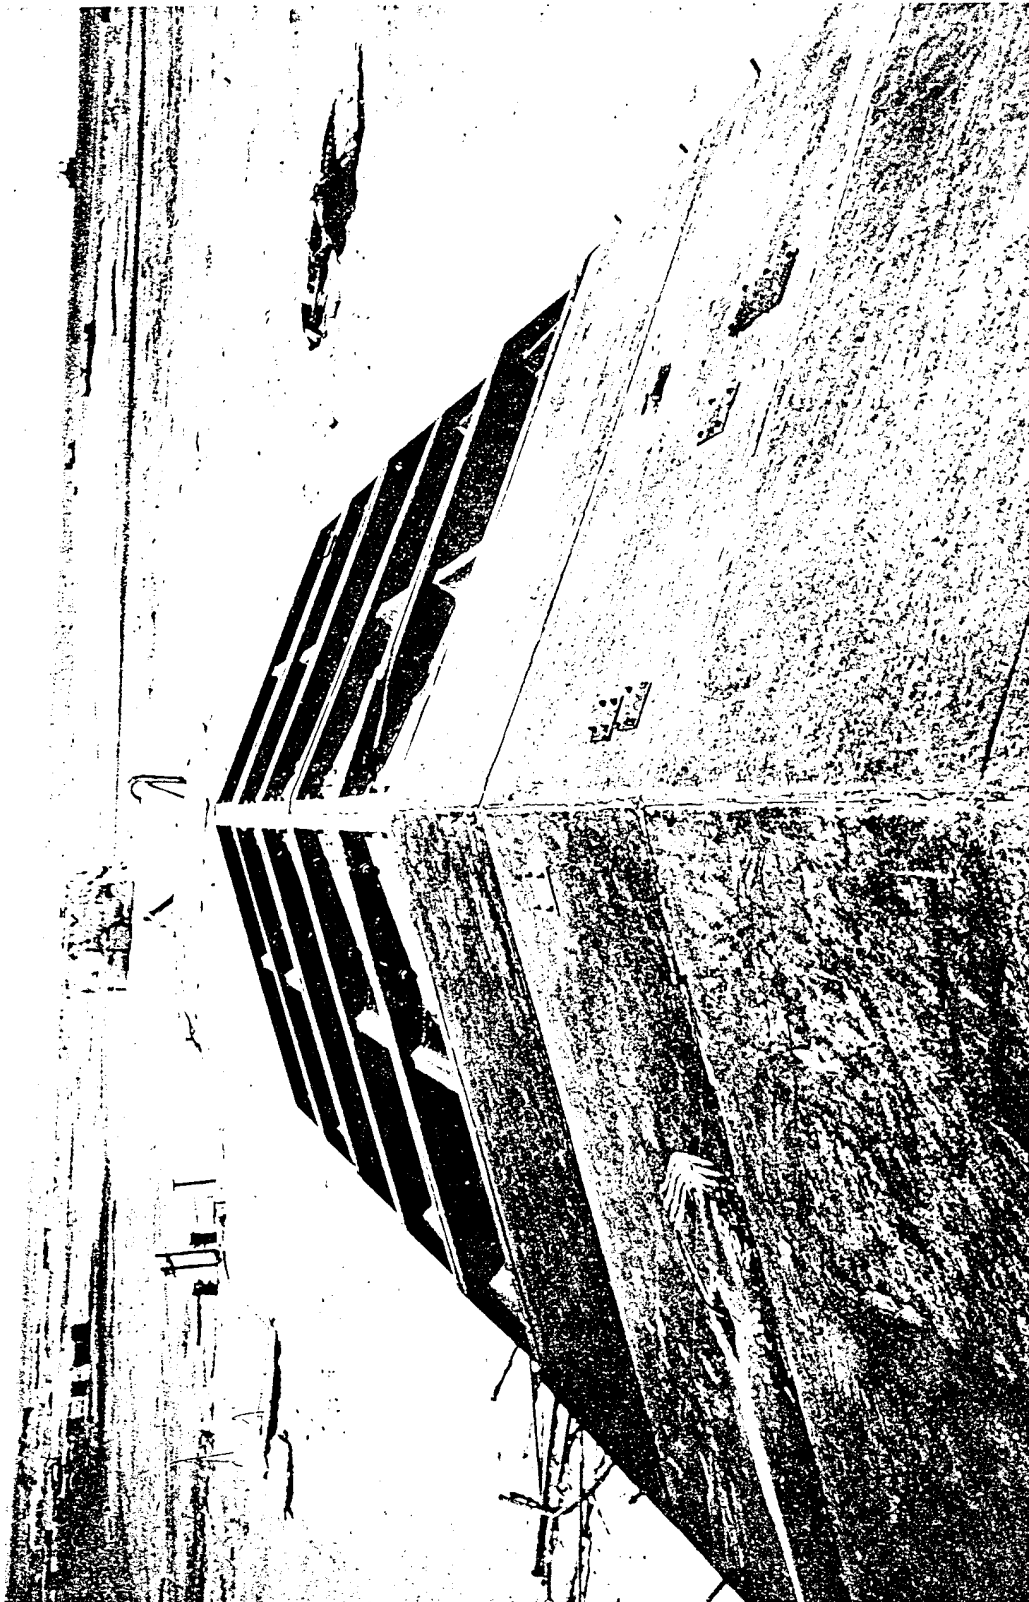
Fig. L.378 Exterior View of Roof Sections, Taken from Left End, Structure 3.2.4b
